## **THE INFAMOUS INTERMEDIATE SHAFT(IMS) SAGA**

\*Information compiled from LN Engineering\*

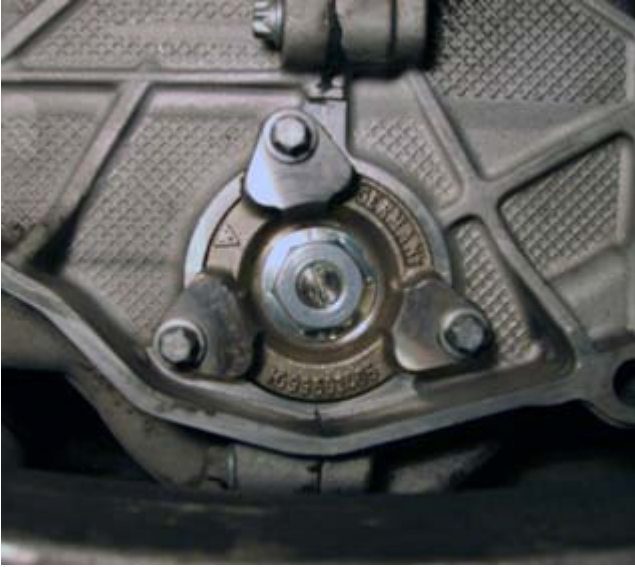
All MY06 through MY08 engines will have the larger single row ball-bearing identified by the larger 22mm nut. These cannot be serviced without complete disassembly of the engine due to the intermediate shaft being redesigned! LN Engineering does offer a MY06-08 IMS Retrofit kit

for the larger bearing found on model year 2006 through 2008 M97 engines, but engine disassembly is required for installation.
