THE INFAMOUS INTERMEDIATE SHAFT(IMS) SAGA

Information compiled from LN Engineering

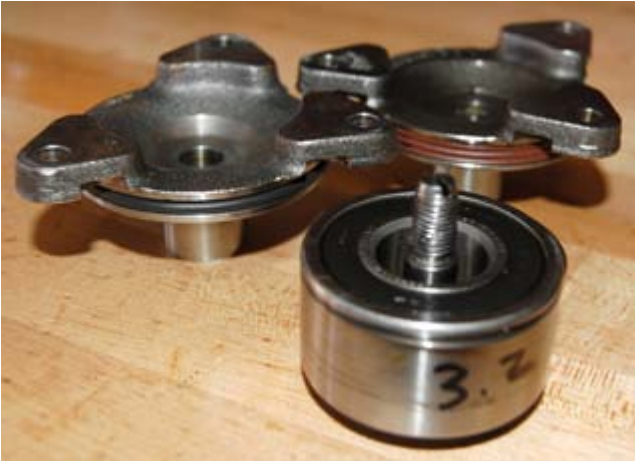
MY00-01 vehicles *may need either a dual row or single row Retrofit™ kit*, so you must inspect the flange and compare to the photos of the dual row and single row IMS shown below to determine which kit is needed.

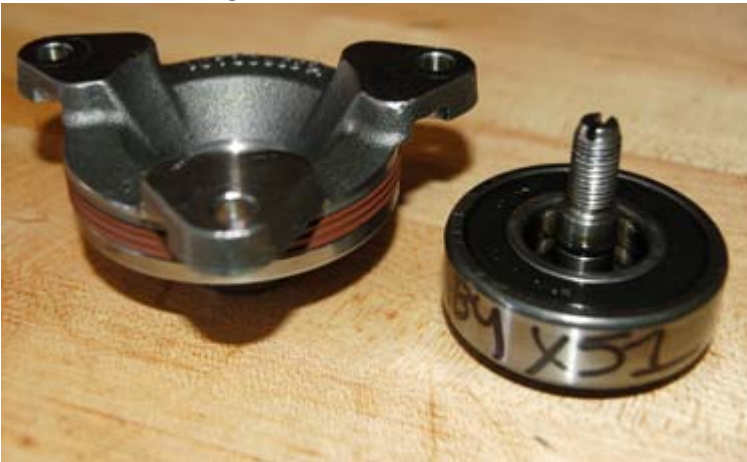
MY02-05 will need a single row Retrofit™ kit, identified by a narrower single row ball-bearing and wider IMS flange.

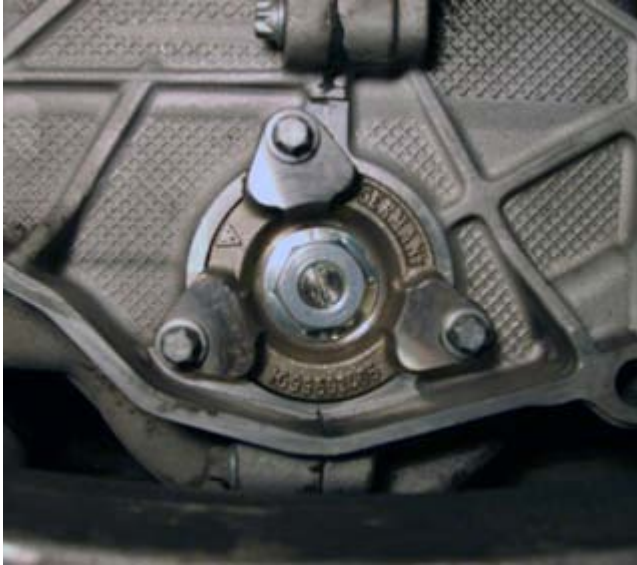
All MY06 through MY08 engines will have the larger single row ball-bearing identified by the larger 22mm nut. These cannot be serviced without complete disassembly of the engine due to the intermediate shaft being redesigned! LN Engineering does offer a MY06-08 IMS Retrofit kit

for the larger bearing found on model year 2006 through 2008 M97 engines, but engine disassembly is required for installation.
