## **THE INFAMOUS INTERMEDIATE SHAFT(IMS) SAGA**

\*Information compiled from LN Engineering\*

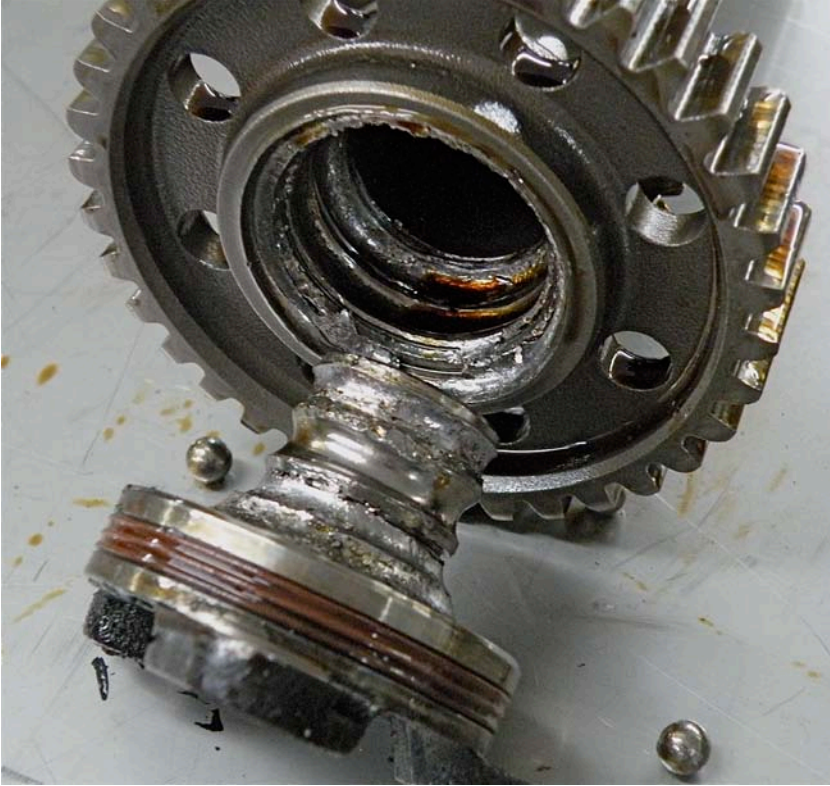
The most common deficiency with the M96 engine and its revisions through 2008 is the failure of the ball-bearing found in the intermediate shaft. The intermediate shaft found in the M96 and later M97 engine was revised three times. The earliest design incorporated a dual-row ball-bearing used through model year 1999 and in some 2000 and 2001 models. Starting in model year 2000, Porsche began phasing out the dual row bearing and went to a smaller single row, with significantly less load capacity. From model year 2002 -2006, all engines used this smaller, lower capacity bearing. Starting with the 2006 model year, the design was again revised to use a much larger single row bearing with the same load capacity of the early dual-row ball-bearings. This bearing increased in diameter, which increased the bearing and ball speed, further improving the bearing. However, starting with the 2006 model year, Porsche in its third revision of the intermediate shaft bearing, changed over to a design that is not serviceable, leaving later model years with no recourse for addressing this issue with preventative maintenance, which failures still frequent. In all revisions, a sealed ball-bearing was used, rather than allowing for engine oil to lubricate and cool the ball-bearing. There is no recommended service interval for these bearings nor provisions for their replacement from the factory. However, with model year 1997 through 2005 engines, the intermediate shaft bearing thankfully is serviceable and with preventative maintenance, costly repairs can be prevented.

By far, the single row ball-bearing used starting in model year 2000 through 2005 are the most problematic. Based off projections calculated by a fellow Porsche enthusiast and retired bearing engineer from Timken, *they figure a 90% survival rate of the single-row 6204 ball-bearing used in the IMS at 90,000 miles\* – resulting in a staggering 10% failure rate (called the L10 life)!*

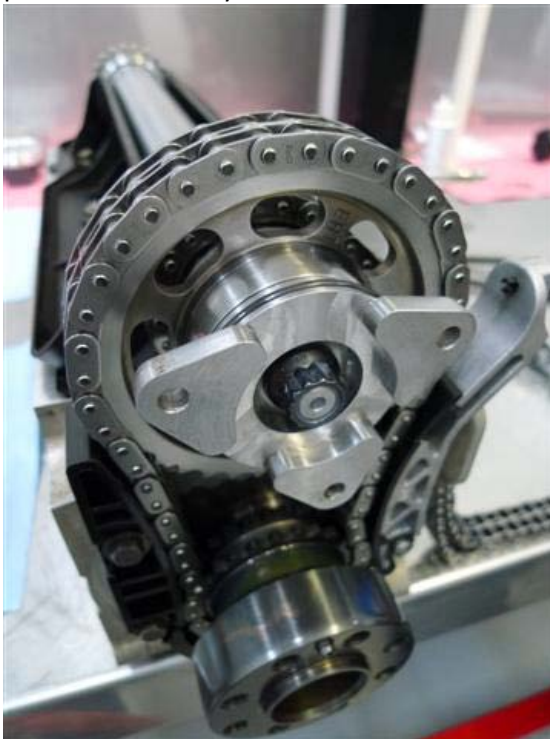
When the M96 engine was developed, for cost savings, one cylinder head casting was made. As such, for interchangeability, the camshafts could no longer be driven off one end of the IMS. This required that the chains be driven off opposite ends of the intermediate shaft. On the rearmost side of the intermediate shaft (closest to the flywheel), you have the main sprocket that drives the intermediate shaft off the crank as well as a smaller sprocket and chain that goes to one of the cylinder heads to drive the cams. Clear on the opposite end of the intermediate shaft there is another sprocket to drive the cams for the opposite cylinder head. This end of the intermediate shaft has a plain bearing surface integrated into the front oil pump console that is pressure fed oil for lubrication directly from the oil pump. As a result, this end of the IMS always performs flawlessly and never shows wear.

Unfortunately, due to how the crankcase was designed, there are no oil passages from which pressurized engine oil can be used to lubricate a plain bearing on the side closest to the flywheel. The IMS in the M96 (and subsequent M97) engine is located directly beneath the crankshaft carrier and is connected to the crankshaft by means of a chain. The IMS has a sealed ball bearing on one end (closest to the flywheel) and a plain bearing on the other end, which resides in the oil pump/coolant console. Additionally, it is this ball-bearing that handles the majority of the load on the intermediate shaft.

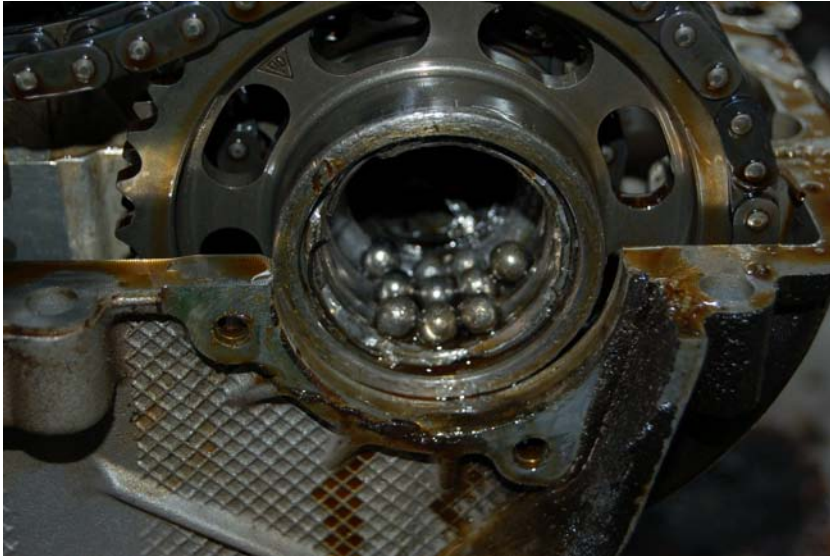
According to information published about the Eisen IMS Class Action Lawsuit, the single row IMS bearing used in 2000 through 2005 model years is reported to have an 8% failure rate, versus less than 1% with the dual row IMS bearing. The 8% failure rate cited by the settlement documents is not far off of the calculated L10 life LN Engineering has been using for the last five

years! With half the load capacity, it is clear to see that the reduced load capacity of the single row IMS bearing is a significant contributing factor to the increased number of failures.

In addition to ball-bearing failures, the intermediate shaft can suffer other failures including but not limited to slippage of drive sprockets which can lead to valve timing related failures. Again, as a cost saving measure, the sprockets were not secured to the intermediate shaft. The center bearing support stud was manufactured with an o-ring groove cut into it, reducing its cross-sectional thickness to less than the diameter of the threads used to secure the IMS bearing assembly. As such, it is common to have the center bearing support stud break during operation, resulting in a large oil leak, and is often an indicator of a failing or failed IMS bearing.

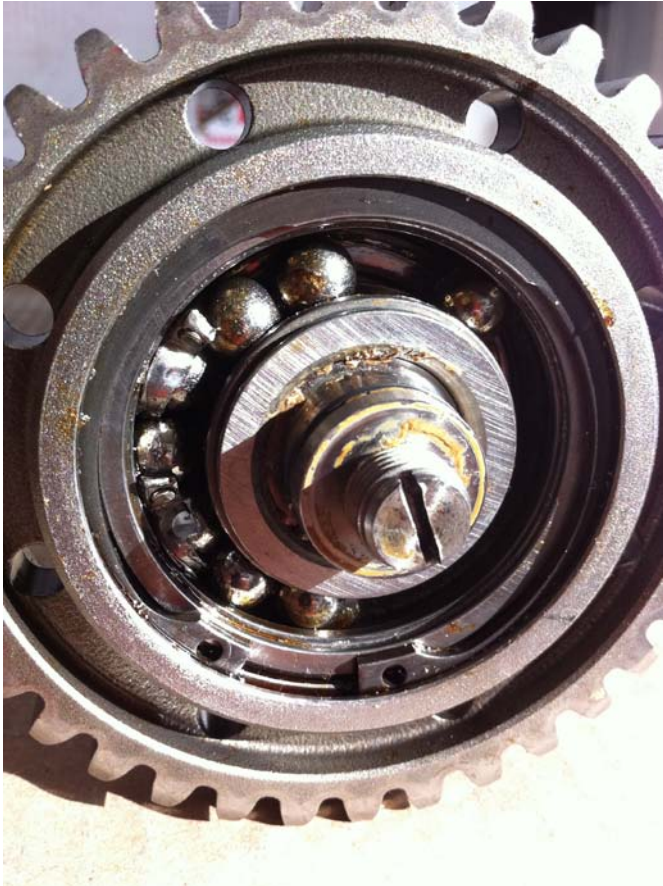
Now for some technical information from our bearing engineering team: "There are many reasons for bearing failure, and usually each failure is due to a combination of causes, not just a single cause. Spalling occurs as a result of normal fatigue where the bearing has reached the end of its normal life span but this is not the most common cause of bearing failure. Spalling

detected in bearings can generally be attributed to other factors. A common cause of bearing failure is due to contamination from tiny metallic particles left over from a previous mechanical failure. These particles are suspended in the oil and if they are allowed to get into the bearing, the result is tiny dents in the hard steel raceway. Often the dent is surrounded by a microscopic raised area (or 'lip'), and when the ball rolls over this lip, the ultra-high point loading exceeds the strength of the steel and it fractures, leaving behind a jagged depression (or 'pit'). Once this cycle begins, wear is greatly accelerated and the bearing will fail prematurely."
